ASBESTOS SURVEY AND LEAD-BASED PAINT SCREENING REPORT

The Railroad Club
2908 P Street
Richmond, Virginia 23223

Issue Date: July 31, 2018

F&R Project Number: 54V-0288

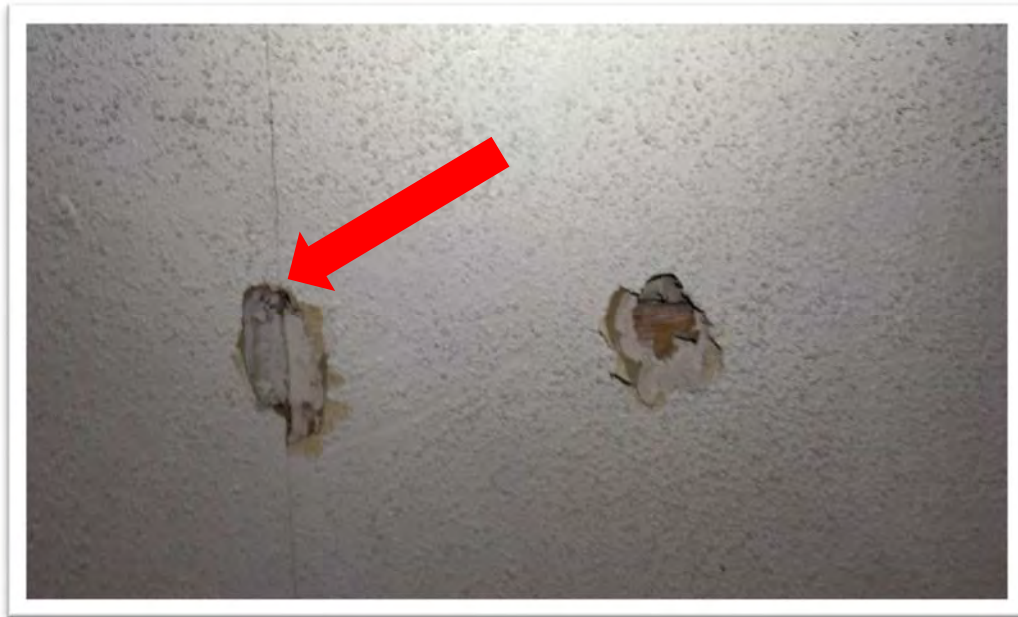
The laboratory was requested to analyze one sample where asbestos was identified (5B) as a composite comprising both joint compound and drywall. The PLM results of the composite sample indicated that the sample composite was <1% Chrysotile. The composite sample was then subjected to a more stringent and lower detection limit point count analytical method and found to be <0.25% Chrysotile. Note that sample layers which were subjected to composite sampling were not collected utilizing the NESHAP methodology specific to composite sampling; however, they were sampled in the field and consequently represent an approximately one to one ratio. This sampling method may not represent the current joint compound to wallboard ratio; however, samples collected with a representative ratio would be further diluted by the non-asbestos-containing wallboard and therefore the overall concentration of asbestos would be further reduced.

Photograph #0003 View of the White Popcorn Textured Drywall (HA #5) located behind the stage in the 2nd Floor Dance Hall area. The arrow indicates the 5B sample location was collected from an apparent seam between the drywall sheets where joint compound was identified as ACM.

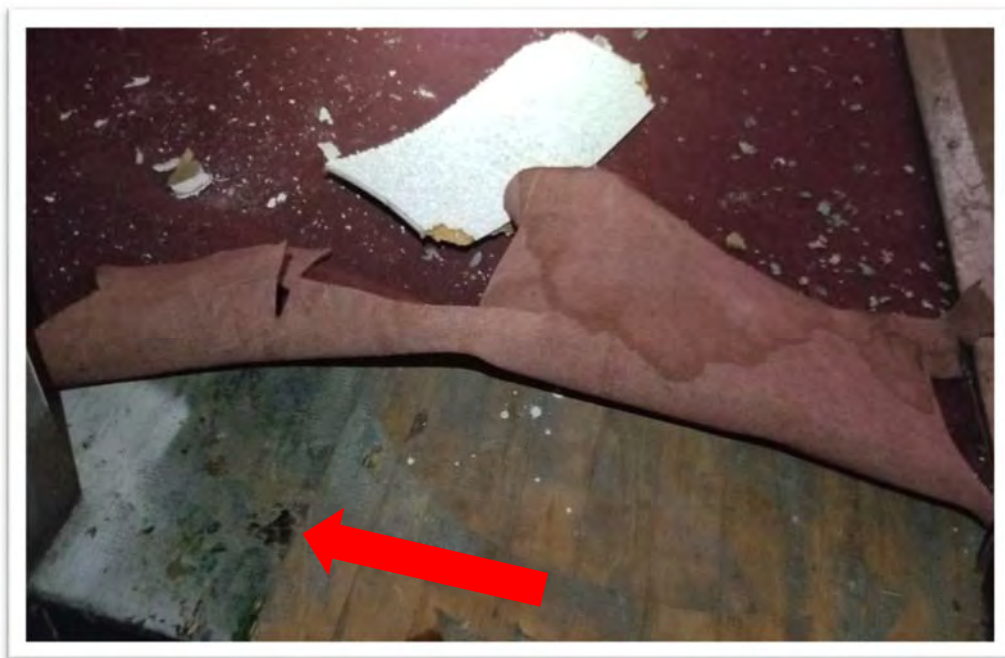
Photograph #0004 View of the dark red colored carpet associated with the 2nd Floor Dance Hall area stage with some of the associated mastic which tested positive for asbestos (Sample ID#s 8A & 8B) visible.

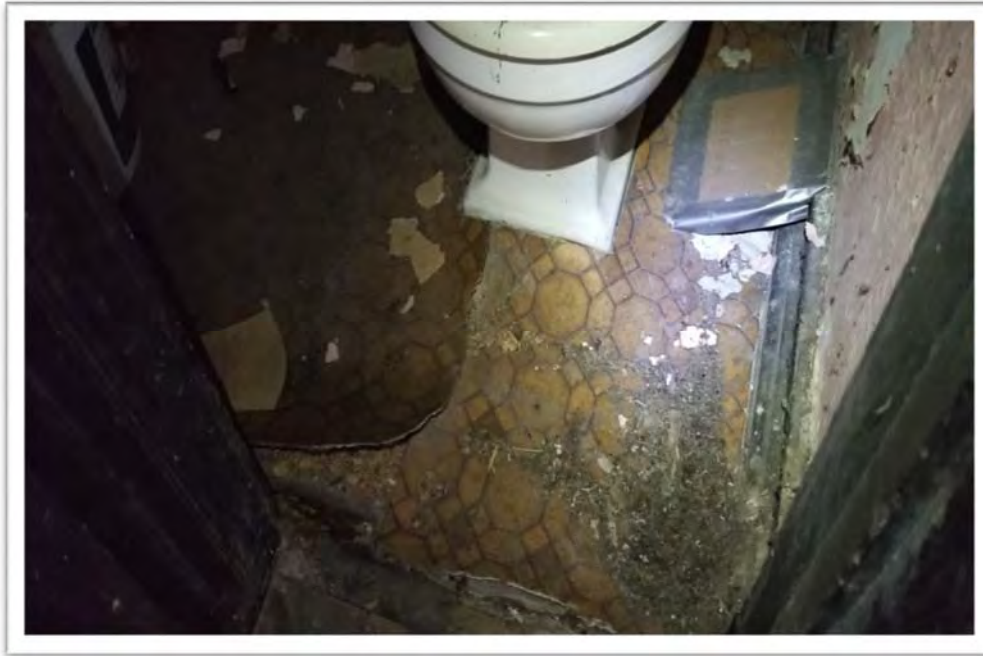
² HA 30: The red brick pattern sheet vinyl flooring and black mastic under the top layer of sheet vinyl flooring tested positive for asbestos in both samples of HA #30. However, in the second sample of HA #30 the black mastic associated with the top layer of sheet vinyl flooring was found to contain asbestos as well. Therefore, all black mastic associated with the top layer of sheet vinyl flooring should be presumed to contain asbestos until otherwise tested. For removal purposes, it is prudent to treat the multilayered floor where mastics and one layer of flooring is ACM as if the entire multilayered floor is ACM.

Photograph #0007 View of one of the bathroom floors from the 1st floor kitchen area section where multiple flooring samples collected were found to be ACM. HA #'s 26, 27, 28, 30, & 3 samples were collected from the flooring in this bathroom, the adjacent stall, and storage closet. .

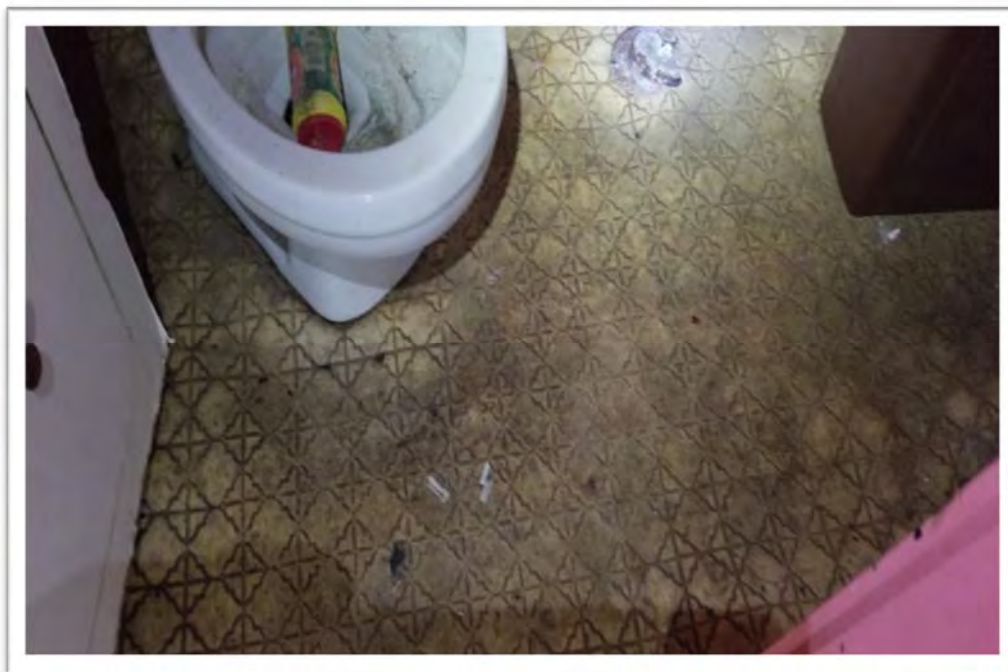
Photograph #0008 View of the other bathroom floor from the 1st floor kitchen area section. Multiple flooring samples (HA #'s 26, 27, 28, 30, 31) were collected from this bathroom and the adjacent bathroom area spaces and tested positive for asbestos. Materials were layered throughout.

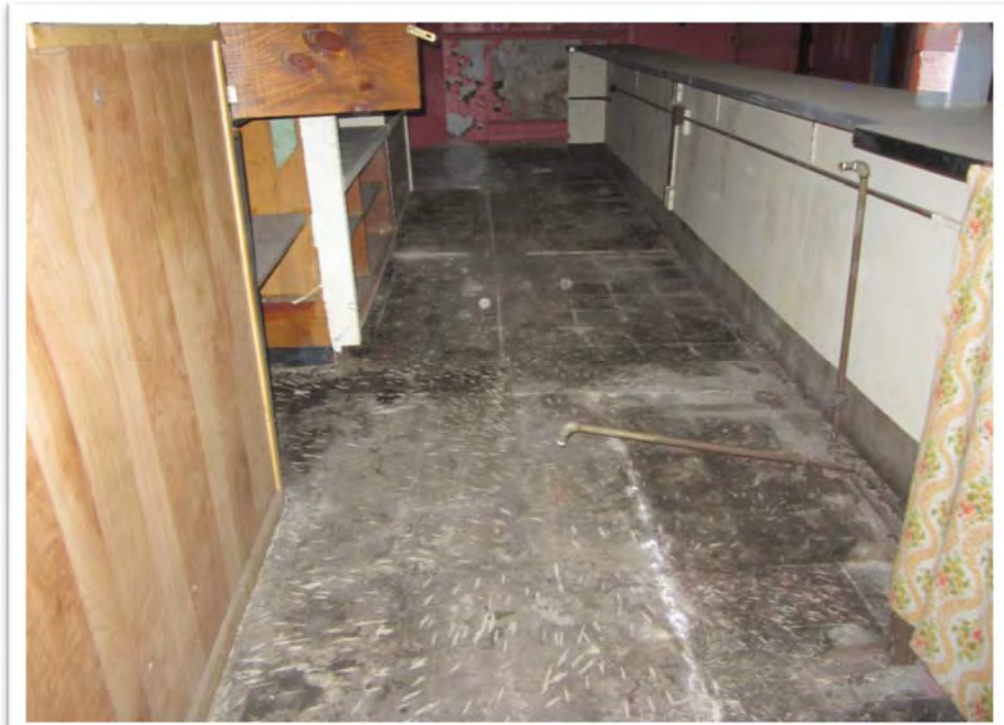
Photograph #0009 View of green vinyl flooring found in the main area of the 1st floor section with a kitchen area (Samples 29A and 29B).

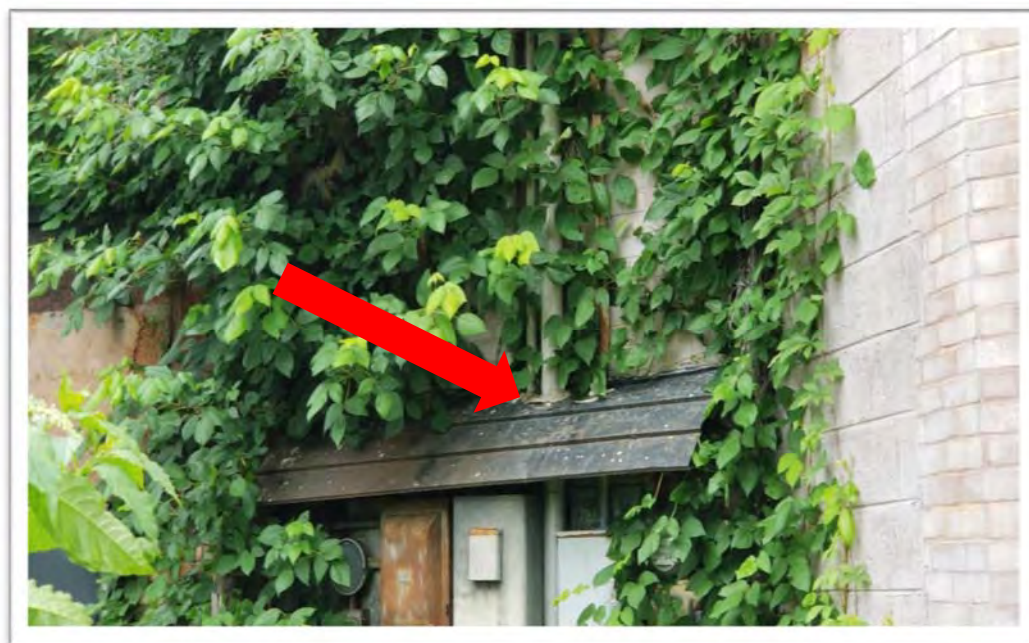
Photograph #0010 View of vertical electrical conduit pipes associated with the electrical panel on the eastern exterior wall of the structure. The arrow points to material collected in samples 39A & 39B. The black tar in the sealant found where the pipes meet the covering contain asbestos.

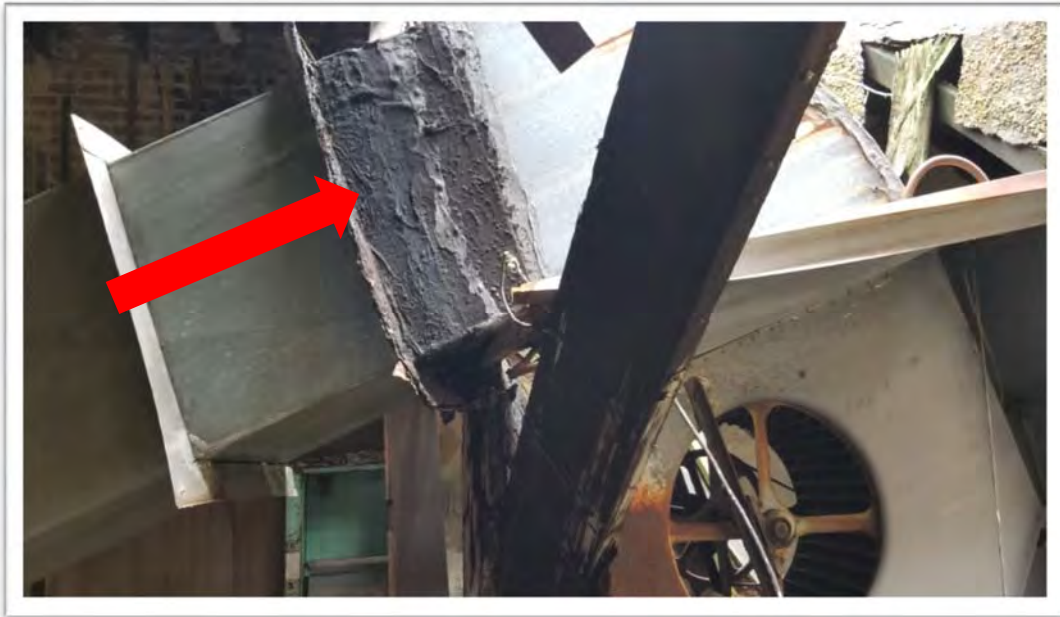
Asbestos (Trace <1%) was detected in the sample of Black Tar sampled from the exterior roof vents (HA #40), and within the tar layer of the roof core (HA #42). Although this concentration of asbestos is below the regulatory threshold under EPA regulations, OSHA has regulations for the removal and disturbance of trace levels of asbestos. While trace concentrations of asbestos were identified in specific roofing layers, other associated roofing layers in the same Homogenous Area were found to be ACM; consequently, all roofing layers which cannot be reasonable segregated should be treated as ACM.

Photograph #0011 View of the exhaust vent associated with the northeast lower roof (roof section is collapsed). The arrow is pointing to black tar present on the exhaust vent used as a sealant. Samples 40A-40C collected from this material were found to contain asbestos.

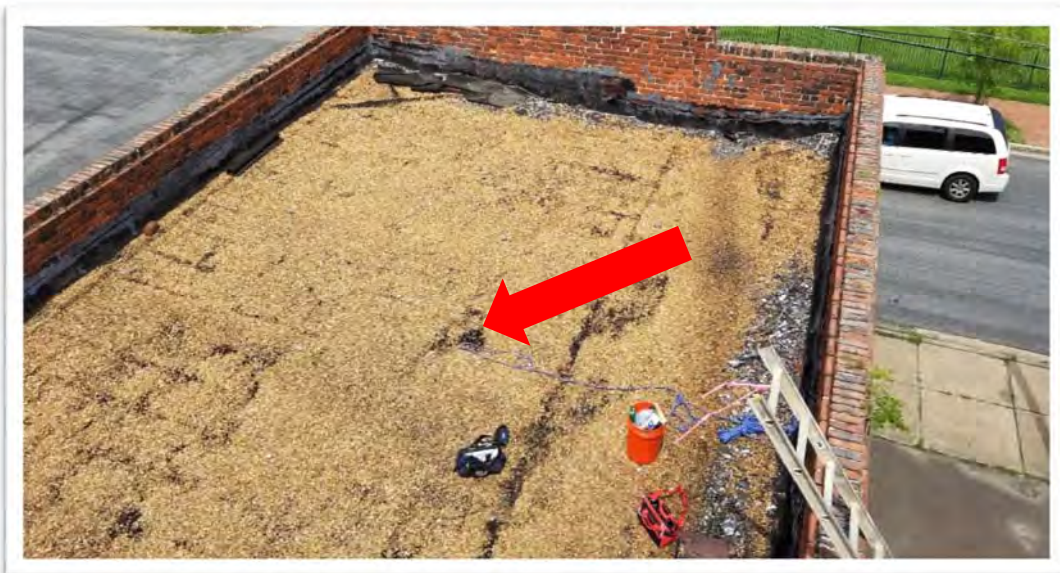
Photograph #0012 View of the southwest low roof. Sample 42A (roof core sample) was collected from the location indicated by the arrow and was found to contain asbestos.

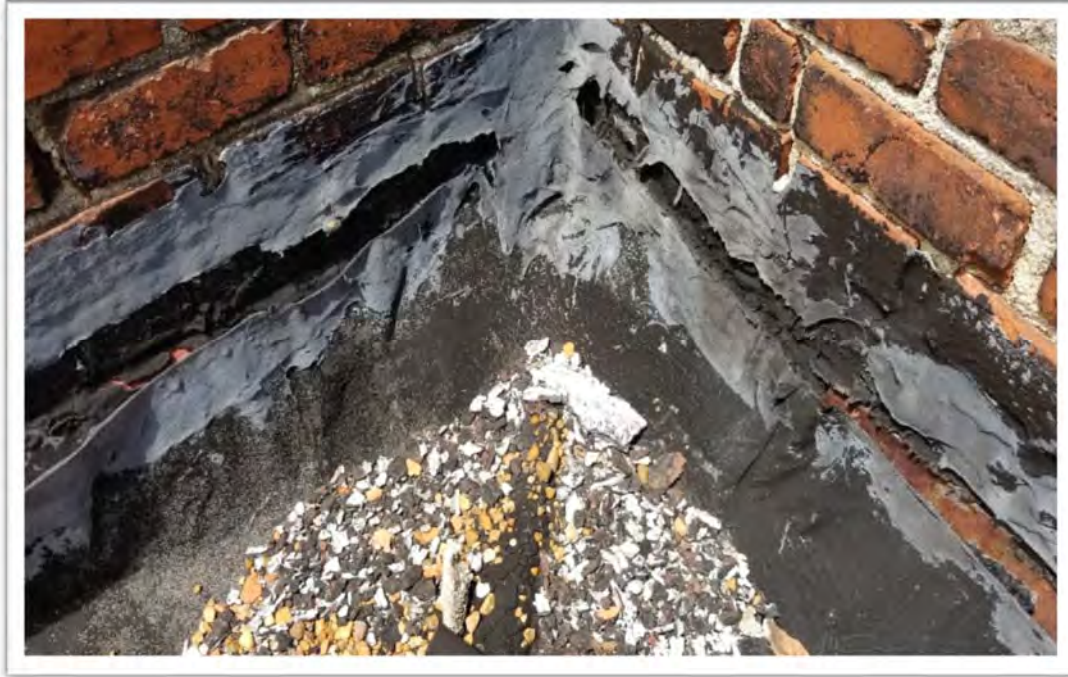
Photograph #0013 View of the sealant materials associated with the parapet wall around the southwest roof. Two separate materials (black tar sealant and gray pliable sealant) were both found to contain asbestos in both samples collected of these materials (43A and 43B).

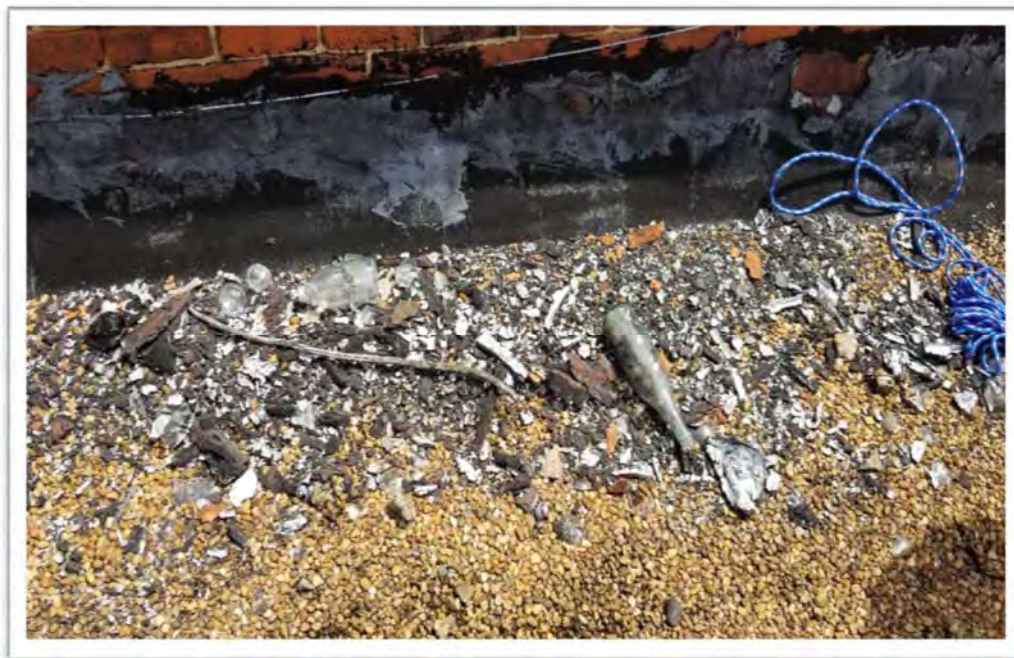
Photograph #0014 View of some of the collected roof debris (Samples 44A and 44B) that is found on the southwest low roof area. The black tar layer and silver paint layer associated with this material were both found to contain asbestos.

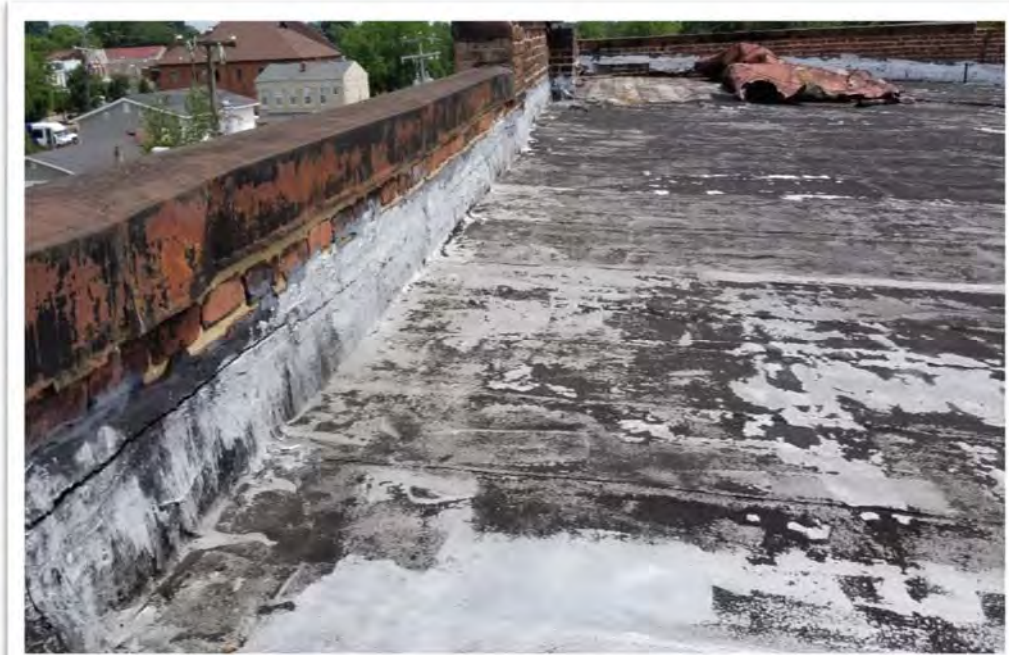
Photograph #0015 View of the high roof area. The black tar roofing membrane layer and silver paint collected in samples 45A and 45B. Both of these materials were found to contain asbestos and are ubiquitous on the high roof area.

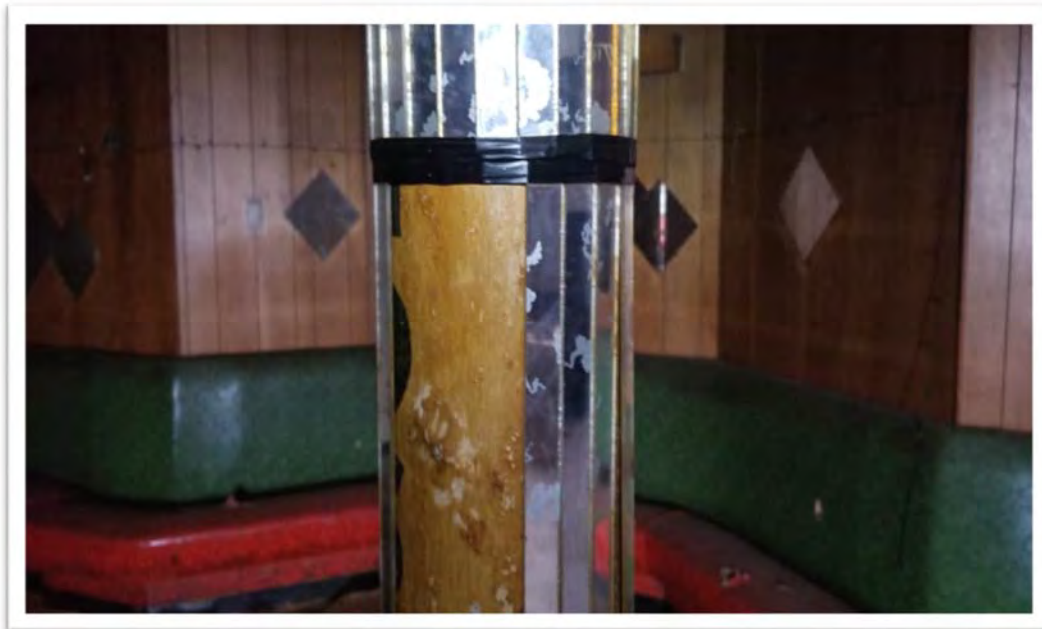
Photograph #0001 View of Lead-Based Paint (LBP) on a metal support column present in the 2nd Floor Dance Hall area.

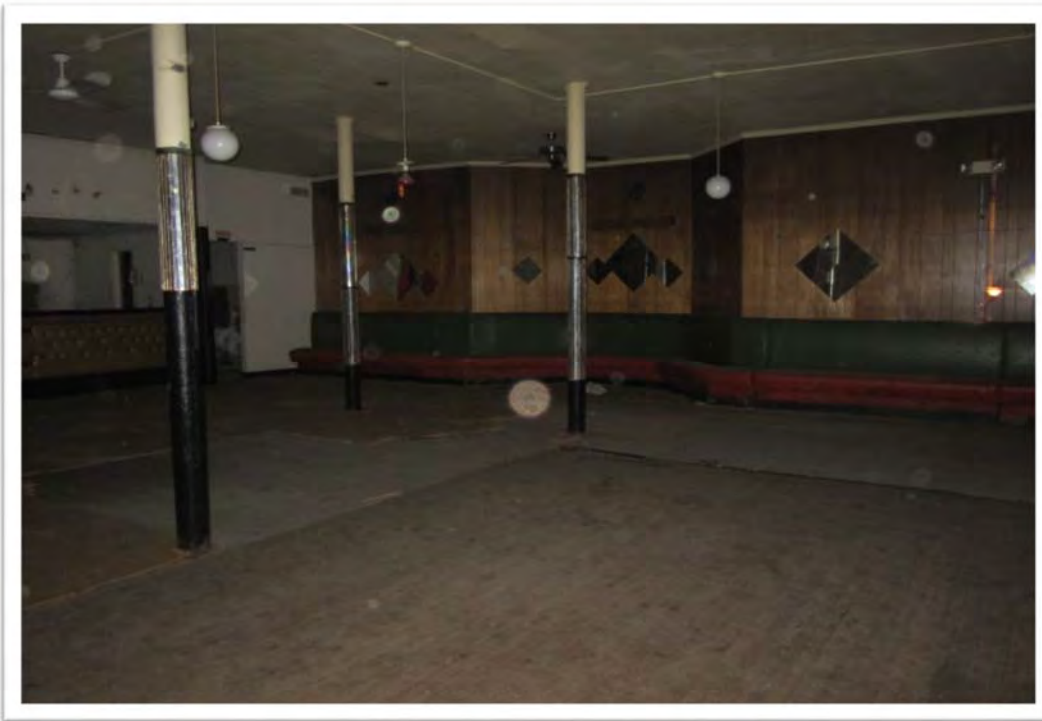
Photograph #0002 View of LBP on metal support columns present in the 2nd Floor Dance Hall area.

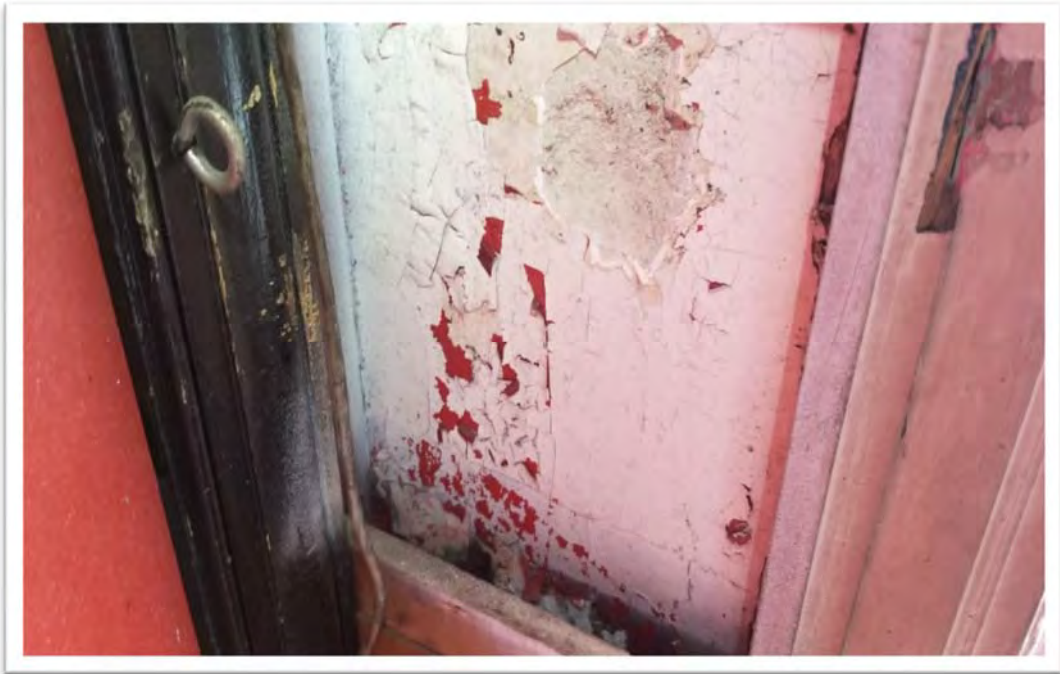
Photograph #0003

View of LBP on a window frame in the 2nd Floor Dance Hall area.

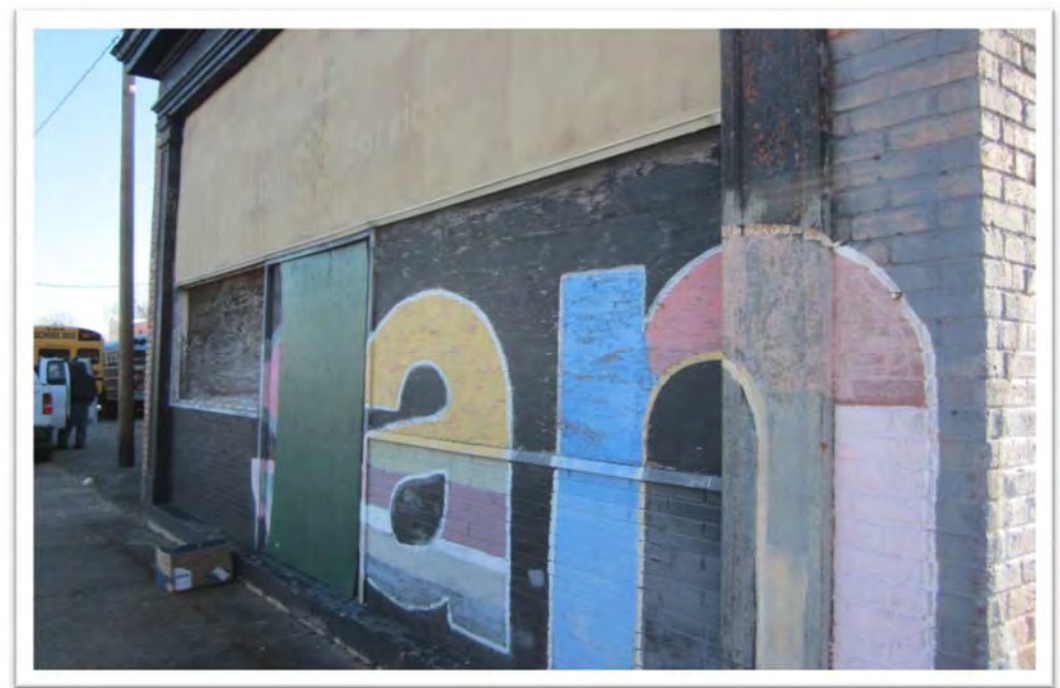
Photograph #0004 View of LBP on a western exterior brick wall.

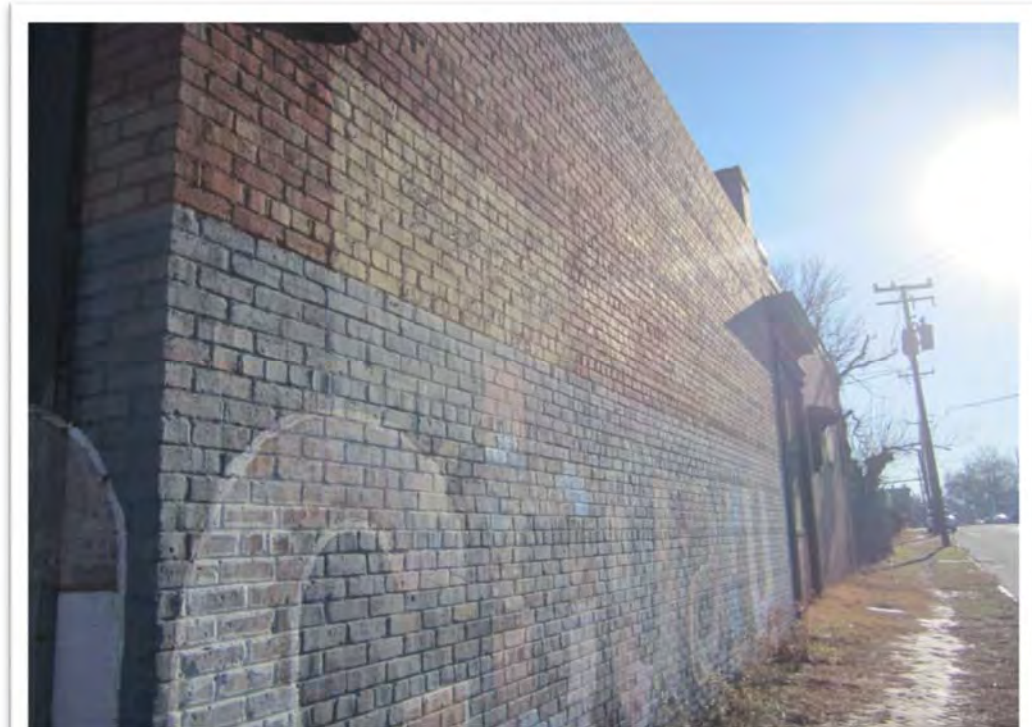
Photograph #0005 View of LBP on the southern exterior brick wall.

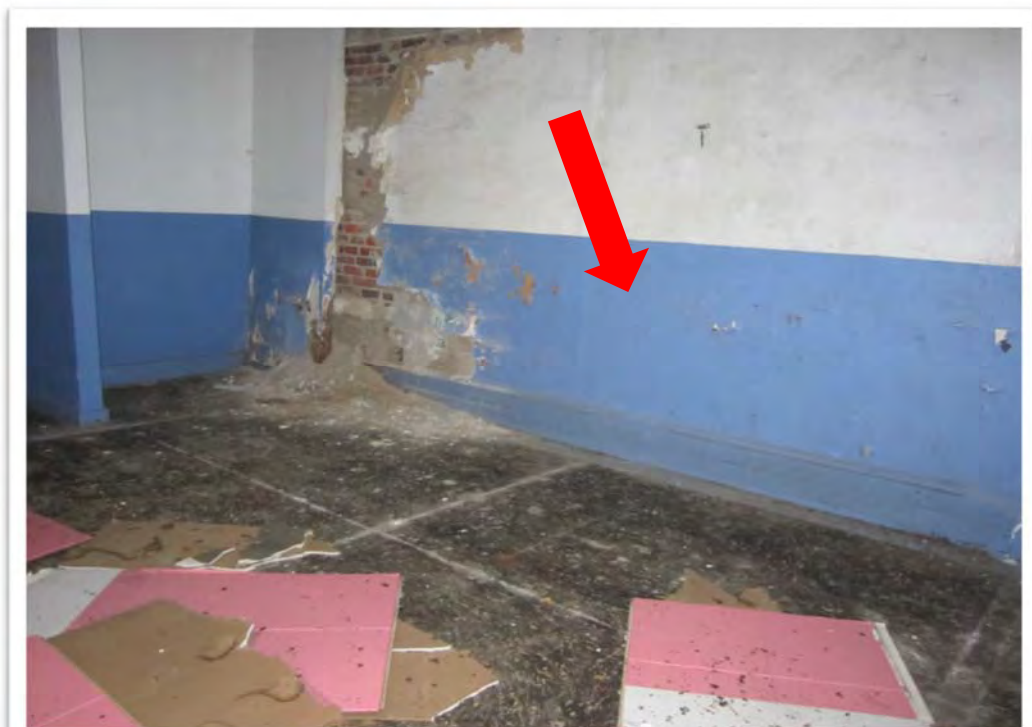
Photograph #0006 Interior of blue LBP present on multiple surfaces in the 1st Floor section that included a Kitchen Area.

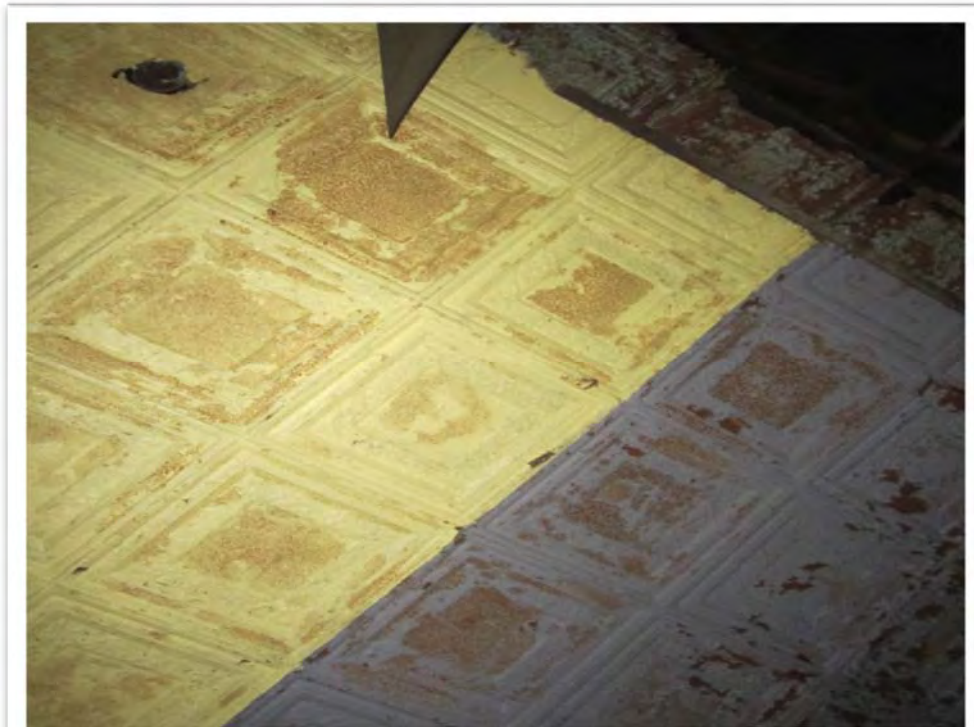
Photograph #0007 View of LBPs on the metal ceilings present in the 1st Floor Dry Cleaners Section of the structure.

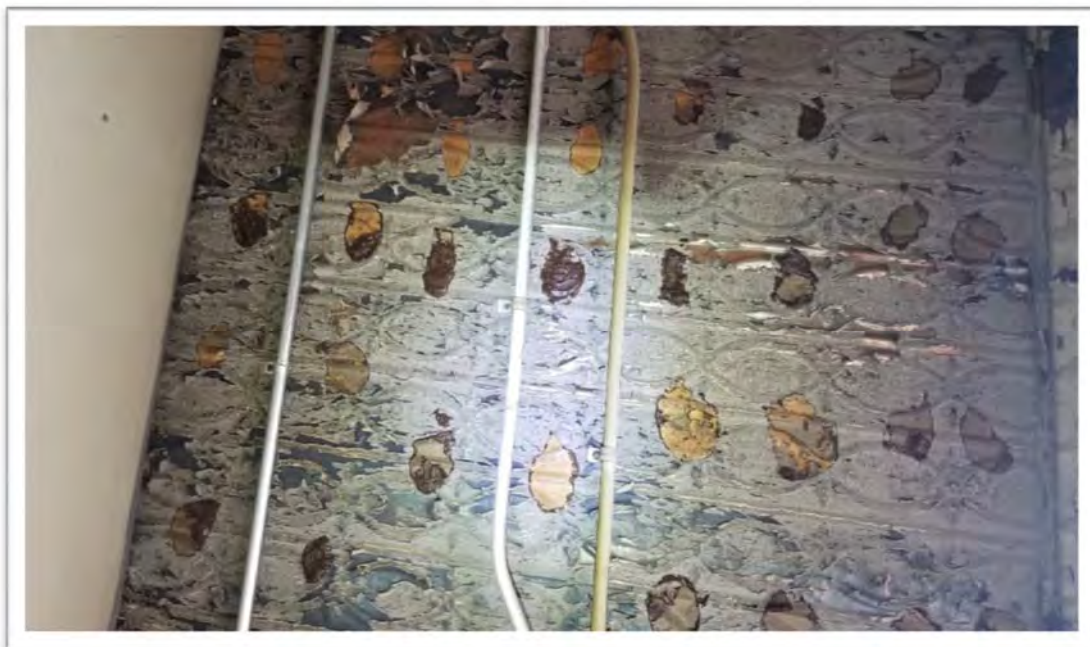
Photograph #0008 View of LBP on the metal ceiling present in the 2nd Floor Dance Hall area. .
